DSTO-TR-0254

Electrostatic and General Hazards
Associated with Cleaning Army Fabric
Bulk Fuel Tanks (TFCs)

**Weapons Systems Division
Aeronautical and Maritime Research Laboratory**

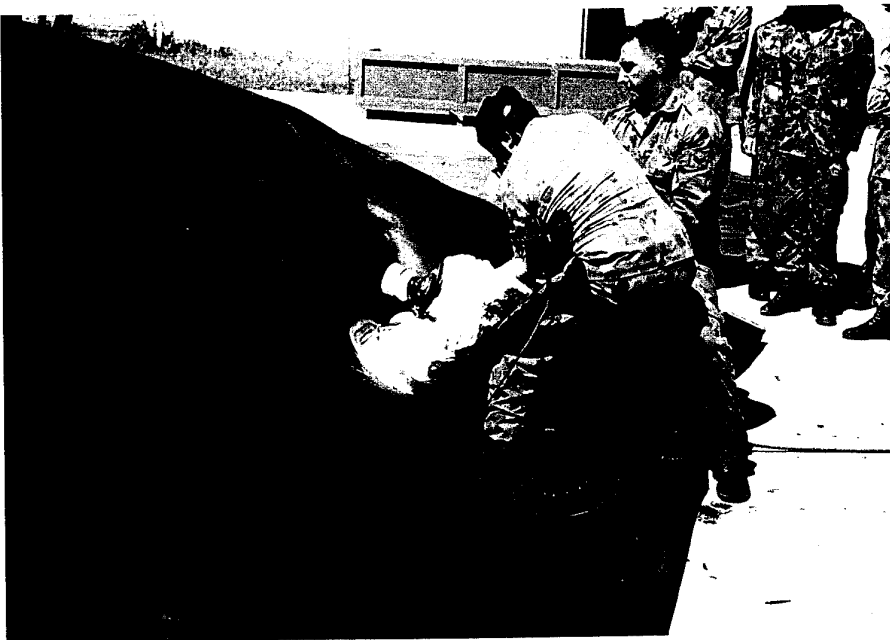
Figure 2: A simulated rescue operation from a TFC.

In the event of a person inside the TFC becoming incapacitated, attendants outside the TFC drag the person to the access hole and safety. This action could be an effective method of inducing electrostatic charge. Accordingly the potential and capacitance measurements (to earth) in Table 5 were conducted for a soldier dragged across the TFC surface while he was lying on his back. The soldier was dressed in DPCU, brown GP boots and either the Saranex or Tyvek overalls. For some measurements the soldier wore a harness.

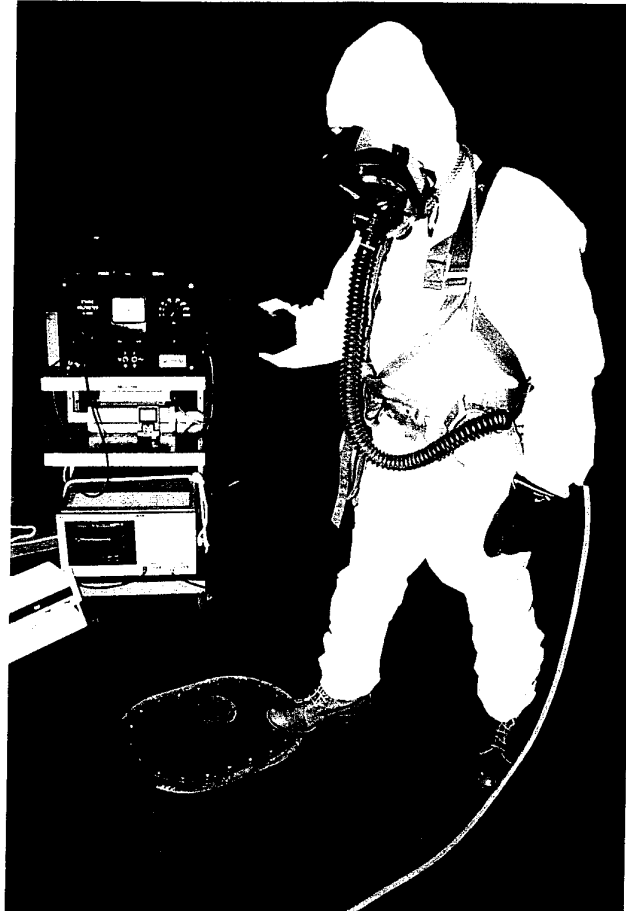
Figure 3: An operator wearing TFC entry attire.
